DOE/ID-11052
Revision 1
January 2003

U.S. Department of Energy
Idaho Operations Office

***Fiscal Year 2002 Operations and Maintenance
Report for the Central Facilities Area,
Operable Unit 4-13***

January 2003

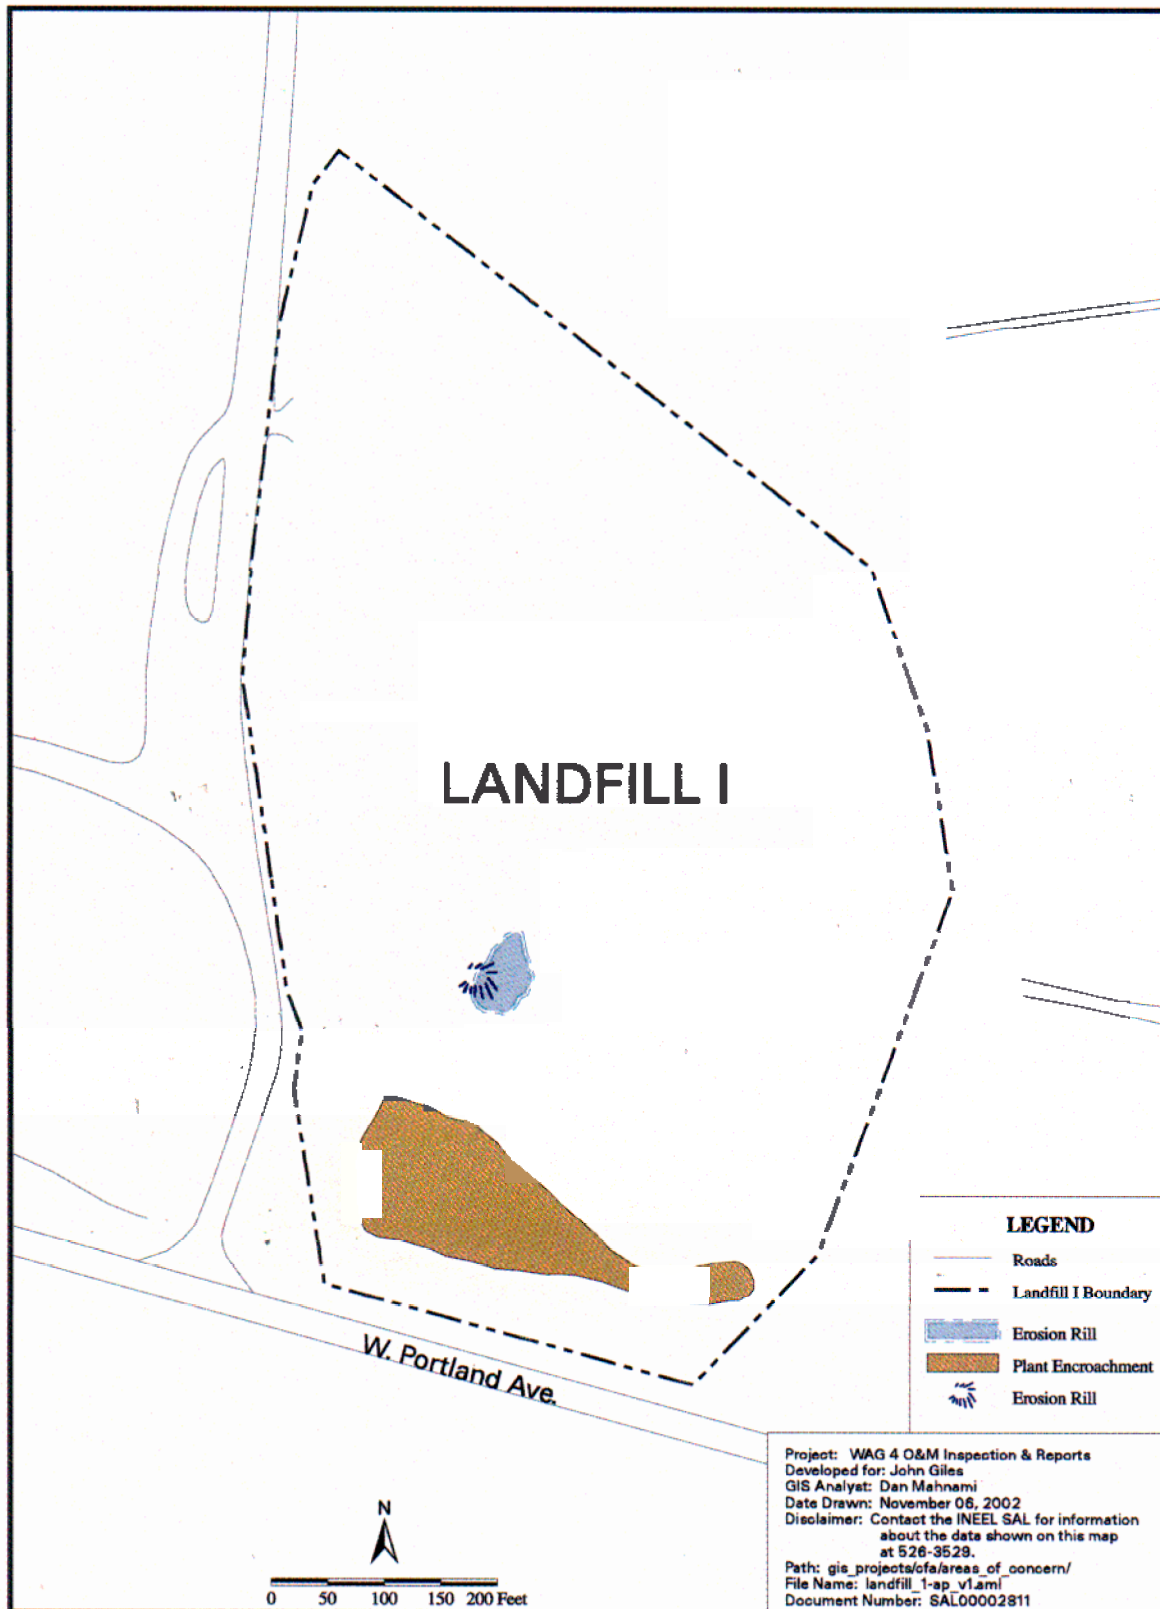
Figure 3-1. CFA-01 Landfill I areas of erosion and plant encroachment identified during FY 2002 inspections.

The soil covers at sites CFA-01, CFA-02 and CFA-03 were inspected for erosion, subsidence and intrusion in accordance with the OU 4-13 O&M plan (DOE/ID 2002). Visual inspections were conducted at each of the landfills to identify areas of concern where the soil covers may have been compromised. The Science Action Team (SAT) study conducted at Landfills I, II and III during the summer of 2002 identified several erosion rills on the landfills, but primarily on Landfill II. There was one area of subsidence identified on Landfill III. Small animal intrusion was also noted on Landfill III. The areas identified during the FY 2002 survey area indicated in Figures 3-1, 3-2 and 3-3.

As specified in the OU 4-13 O&M plan (DOE/ID 2002), the erosion rills and small mammal burrows have been identified for maintenance activities during FY 2003 and are pictured in Appendix B. The rills and burrows will be backfilled and returned to grade. Revegetation of these areas will be completed as necessary.

- Filling and regrading of erosion rills, subsidence, and small mammal burrows.
- Revegetation of the regraded areas and sparse vegetation areas at Landfills II and III identified during the FY 2002 inspections.
- Application of herbicides at Landfills I, II, and III to control the spread of noxious weeds and deep-rooting plants.

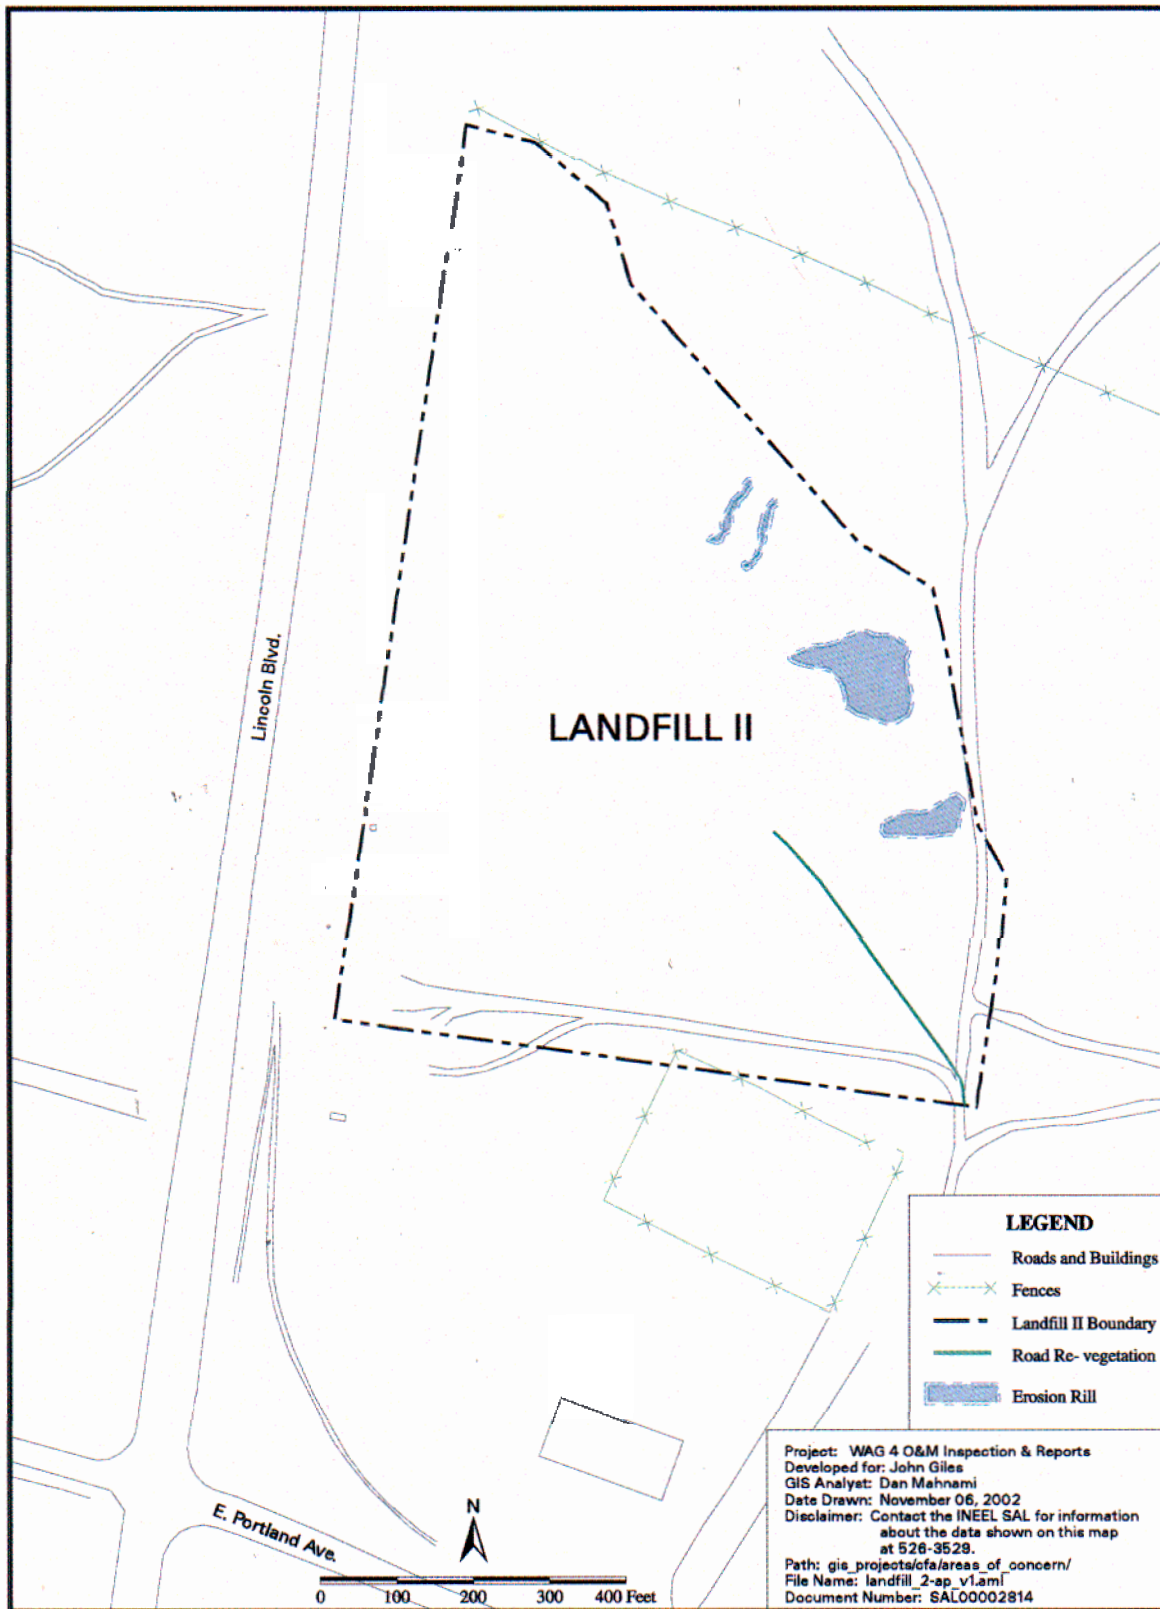
Figure 3-2. CFA-02 Landfill II areas of erosion and sparse vegetation identified during FY 2002 inspections.

There were two areas of sparse vegetation identified during the FY 2002 inspection and the SAT study. These areas occur on Landfills II and III. Landfill II has an area immediately adjacent to the entrance gate in the southeast corner where the vegetation is very sparse from what appears to be vehicle traffic. The sparse area of vegetation extends along a narrow strip in a northwesterly direction towards the time domain reflectometry array located near the center of Landfill II. Landfill III also has an area immediately adjacent to the entrance gate on the east side where the vegetation is very sparse from what appears to be vehicle traffic. These areas have been identified for revegetation maintenance during FY 2003.

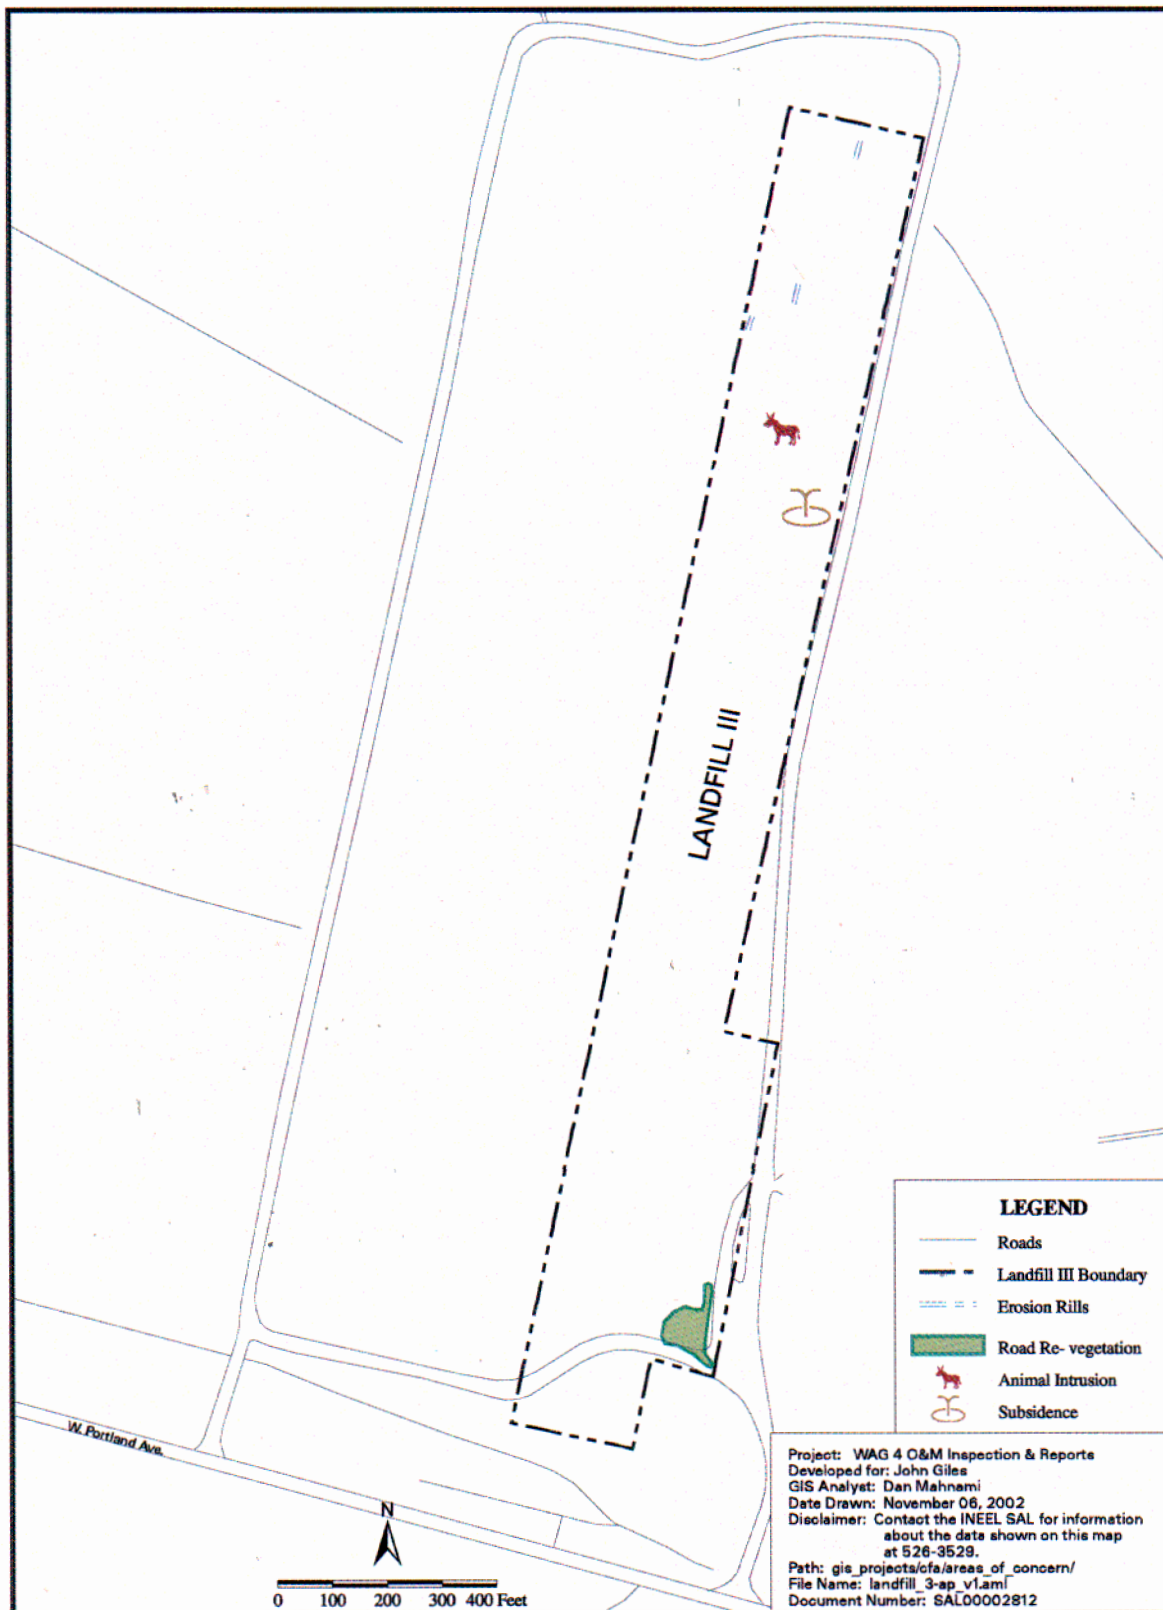
Figure 3-3. CFA-03 Landfill III areas of erosion, subsidence, animal intrusion, and sparse vegetation identified during FY 2002 inspections.

Areas of small mammal burrows were identified primarily on Landfill III, the largest of which is identified in Figure 3-3. This is consistent with the observations of the SAT study results that identified over three times the number of small mammal burrows in Landfill III than in Landfills I and II (Stacey 2002).

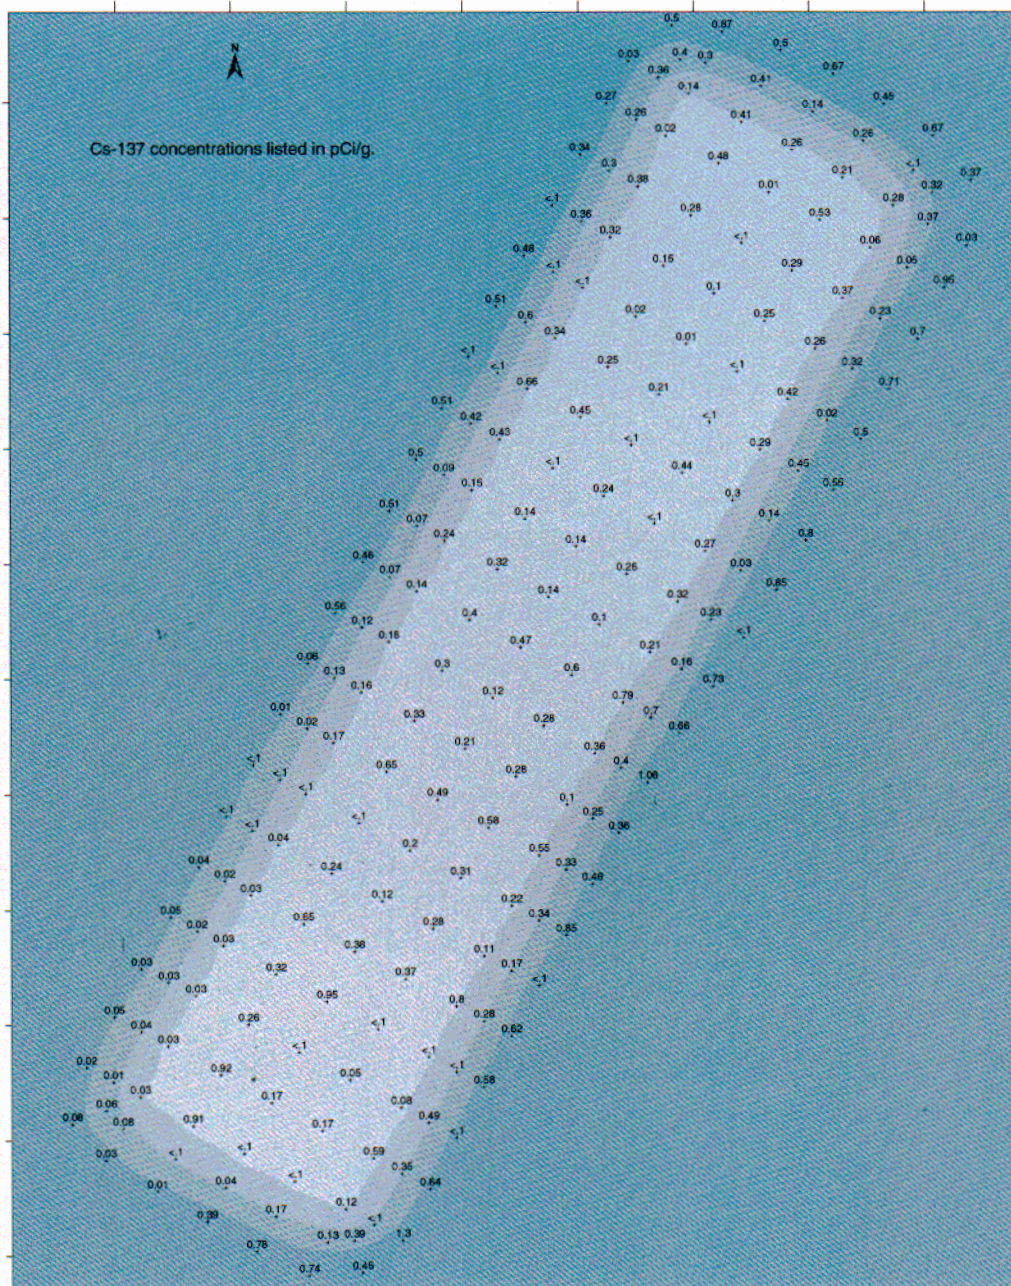
Figure 3-4. CFA-08 radiological survey results, Cs-137 concentrations in pCi/g.

During the radiological survey there were 217 points measured, with 127 positive detects at the 95% confidence level. The Cs-137 concentrations ranged from 0.01 ± 0.003 pCi/g to 1.3 ± 0.36 pCi/g (2-sigma uncertainty). The average concentration was 0.35 pCi/g with a standard deviation of 0.27 pCi/g. The 95 % upper tolerance limit at the 95% confidence level for the background Cs-137 concentration at the site as reported by Rood, et al., is 0.82 pCi/g. The remaining 90 points that were measured were below the lower limit of detection of the system. Based on the results of the radiological survey, it is conclusive that Cs-137 levels in the surface soils of the newly constructed engineered cover are below the INEEL background concentrations.
